# FY2015 Capital Plan Water Department

February 3, 2014

# Water Department FY2015 Capital Requests

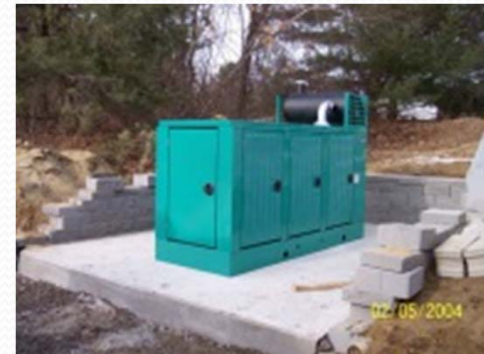
- Phase II includes upgrading station components and bringing new wells online.
  - Install necessary piping to wells
  - Install new well pumps
  - Replace existing electrical controls
  - Modify control system to operate new wells
  - Install natural gas fired emergency generator
  - Remove old equipment & piping
  - Decommission existing vacuum wells
- Requesting \$100,000 from retained earnings for design and permitting needed to start Phase II

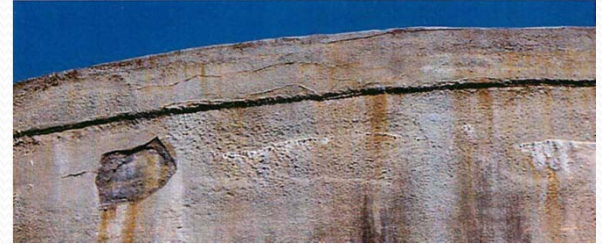
- Two, ½ million gallon concrete tanks.
  - Boston Street constructed in 1949
  - Garden Street constructed in 1972
- Inspection conducted in 2011 identified deficiencies
  - Spalling & cracked concrete at both tanks
  - Corroded bolts on vent at Garden Street
  - Corroded hatch at Boston Street
- Repair work deferred one budget cycle due to funding concerns

- Requesting \$250,000 from retained earnings for storage tank repair and improvements.
  - Design work currently underway.
- Scope of work includes:
  - Repair work identified during inspections
  - Safety improvements
    - Roof access & fall prevention
  - Install active mixing system
    - Reduces temperature gradients - prevents internal ice damage and extends life of the tank.
    - Reduces chlorine gradients – water quality in the tank is more consistent.

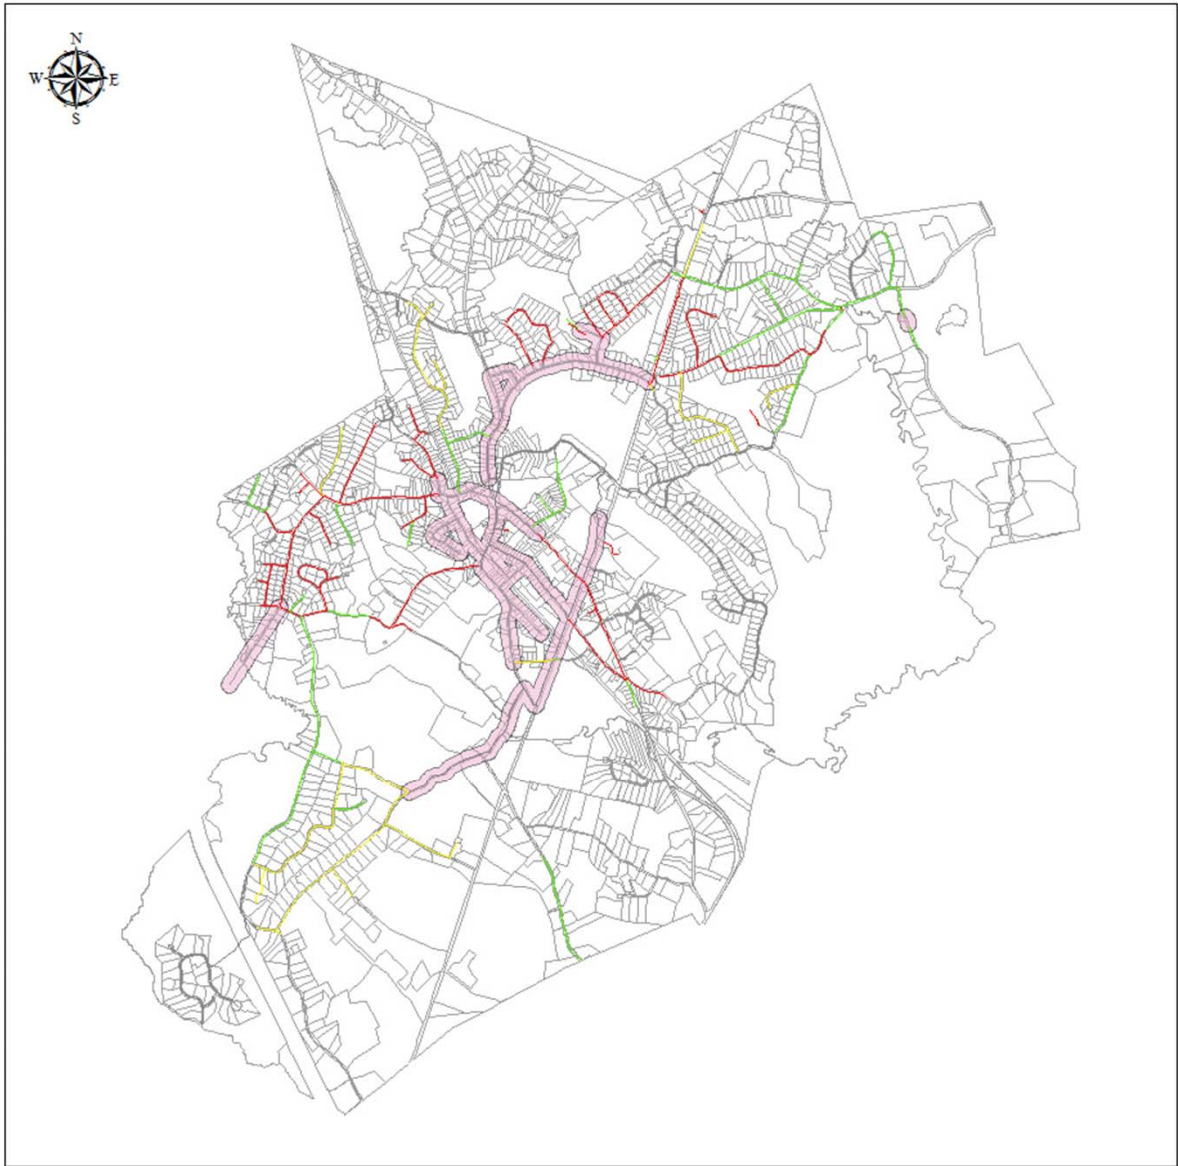
## Capital Project Map

This map shows parcels and Town owned water mains coded by installation decade.

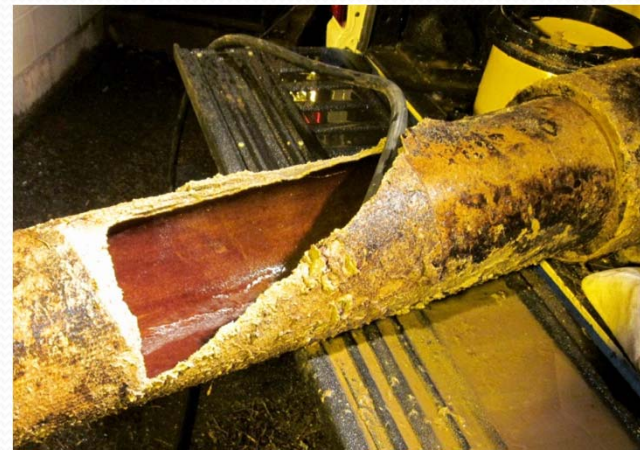
This is a typical water main break in an 8 inch concrete pipe. This section was removed from a break on Washington Street in October 2011.

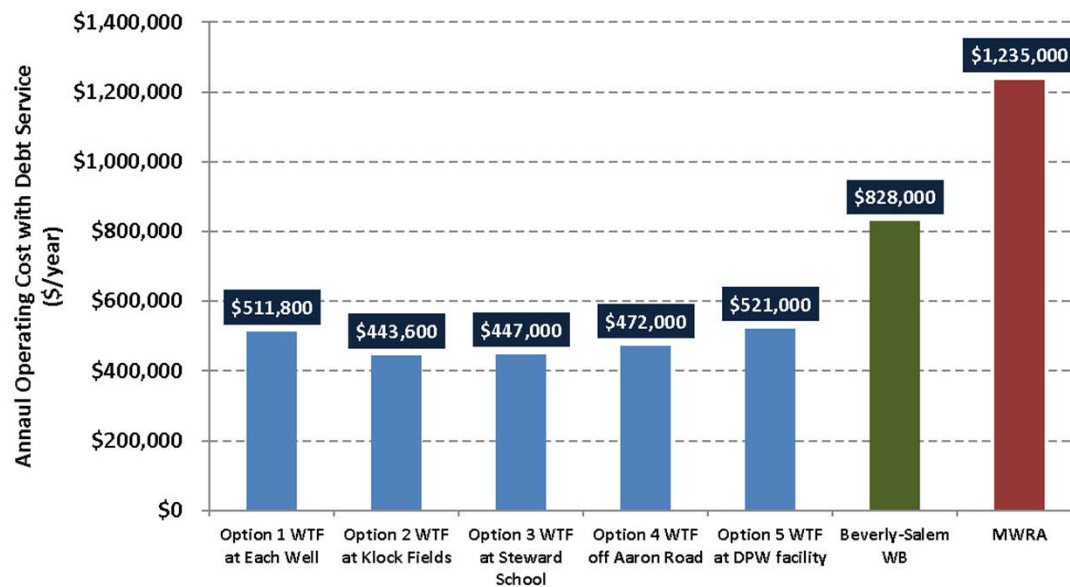
**FIGURE 5-5  
COMPARISON OF ANNUAL OPERATING COSTS FOR TREATMENT ALTERNATIVES  
USING OXIDE-COATED HIGH RATE FILTRATION WITH MWRA\*  
TOPSFIELD, MA**

\*Costs in Figure 5-5 for the MWRA and BSWB infrastructure costs to extend water into the Town of Topsfield from the terminus of the MWRA system in Peabody or from the BSWB system.

- Centralized greensand filter selected because:
  - Easiest and least expensive treatment alternative to operate
  - Provides compliance with Groundwater Rule
  - Provides protection against possible Surface Water Treatment Rule requirements
  - Adjacent towns unable/unwilling to supply water
    - High priority given to obtaining water from outside Ipswich River Basin.
  - MWRA connection fee and piping deemed too expensive.

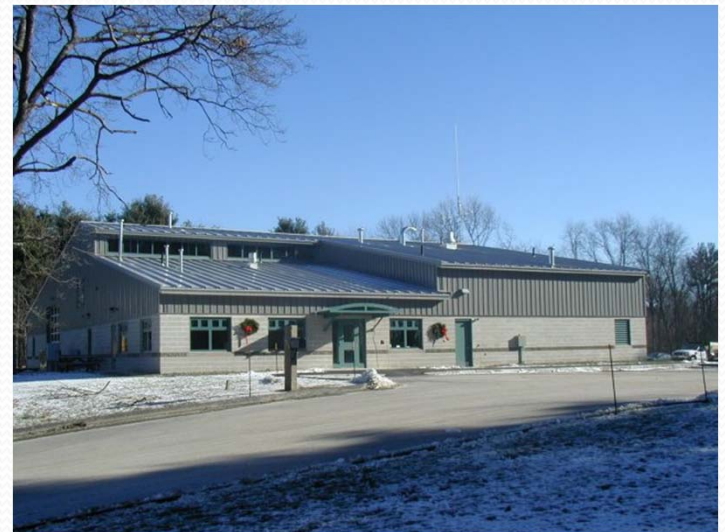
- Location selected because:
  - Small amount of uplands at sources
  - Public Works Facility already developed for similar purpose
  - Minimal permanent impact on residents and neighbors
